CEE 4674

Embraer 145 Overrun Event at ROA Airport (September 24, 2025)

Dr. Antonio A. Trani
Fall 2025

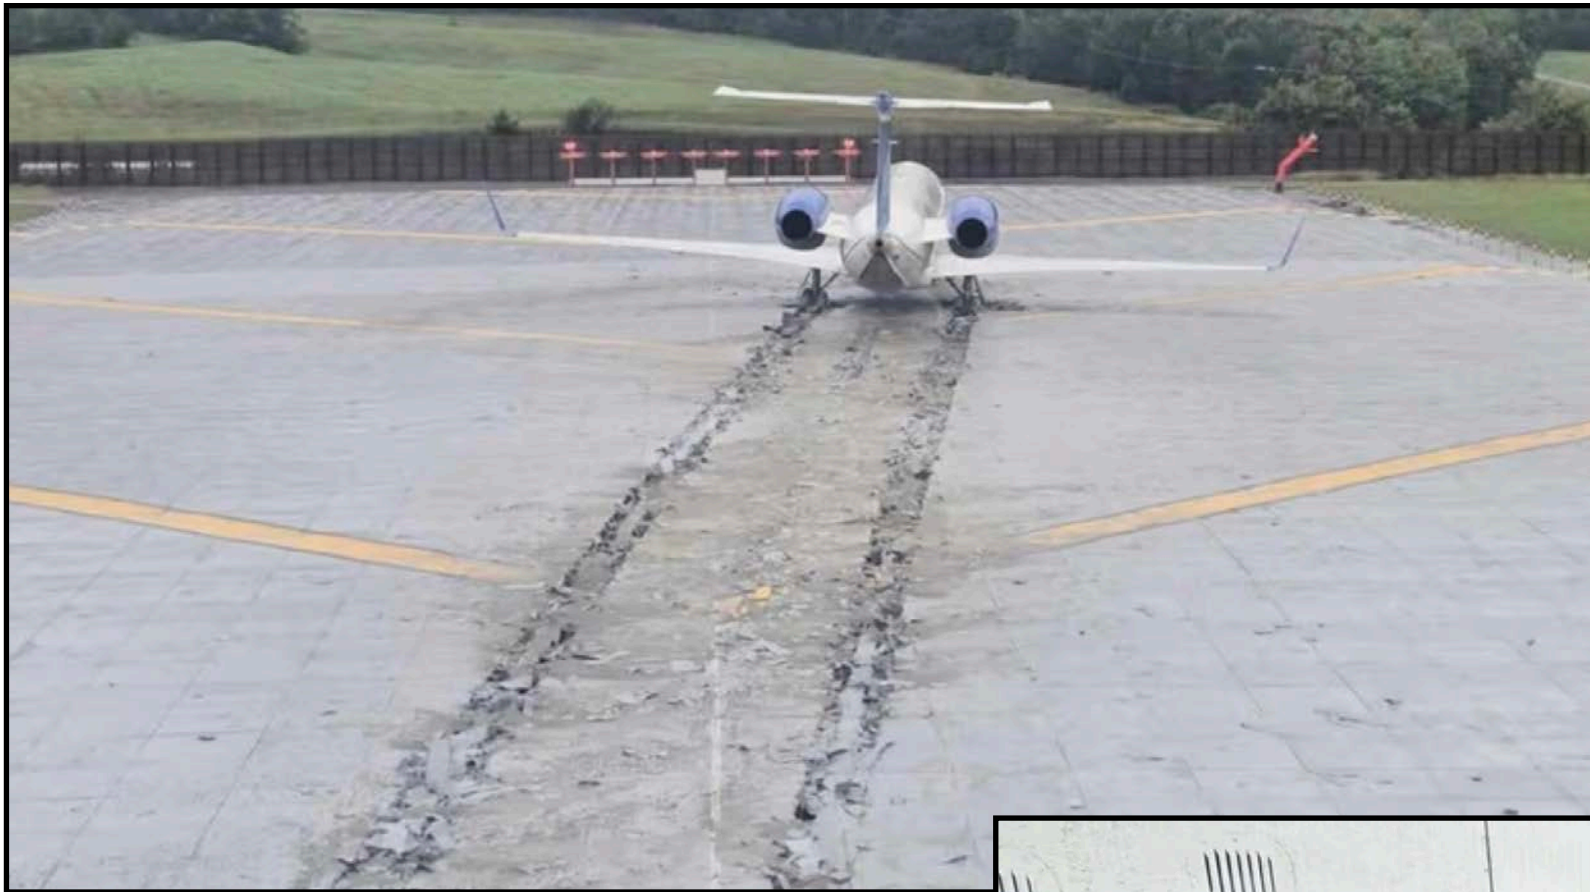
Aircraft used
~180-200 feet of
the EMAS bed

Aircraft probably
entered the EMAS
bed at ~45 knots
(my estimate)

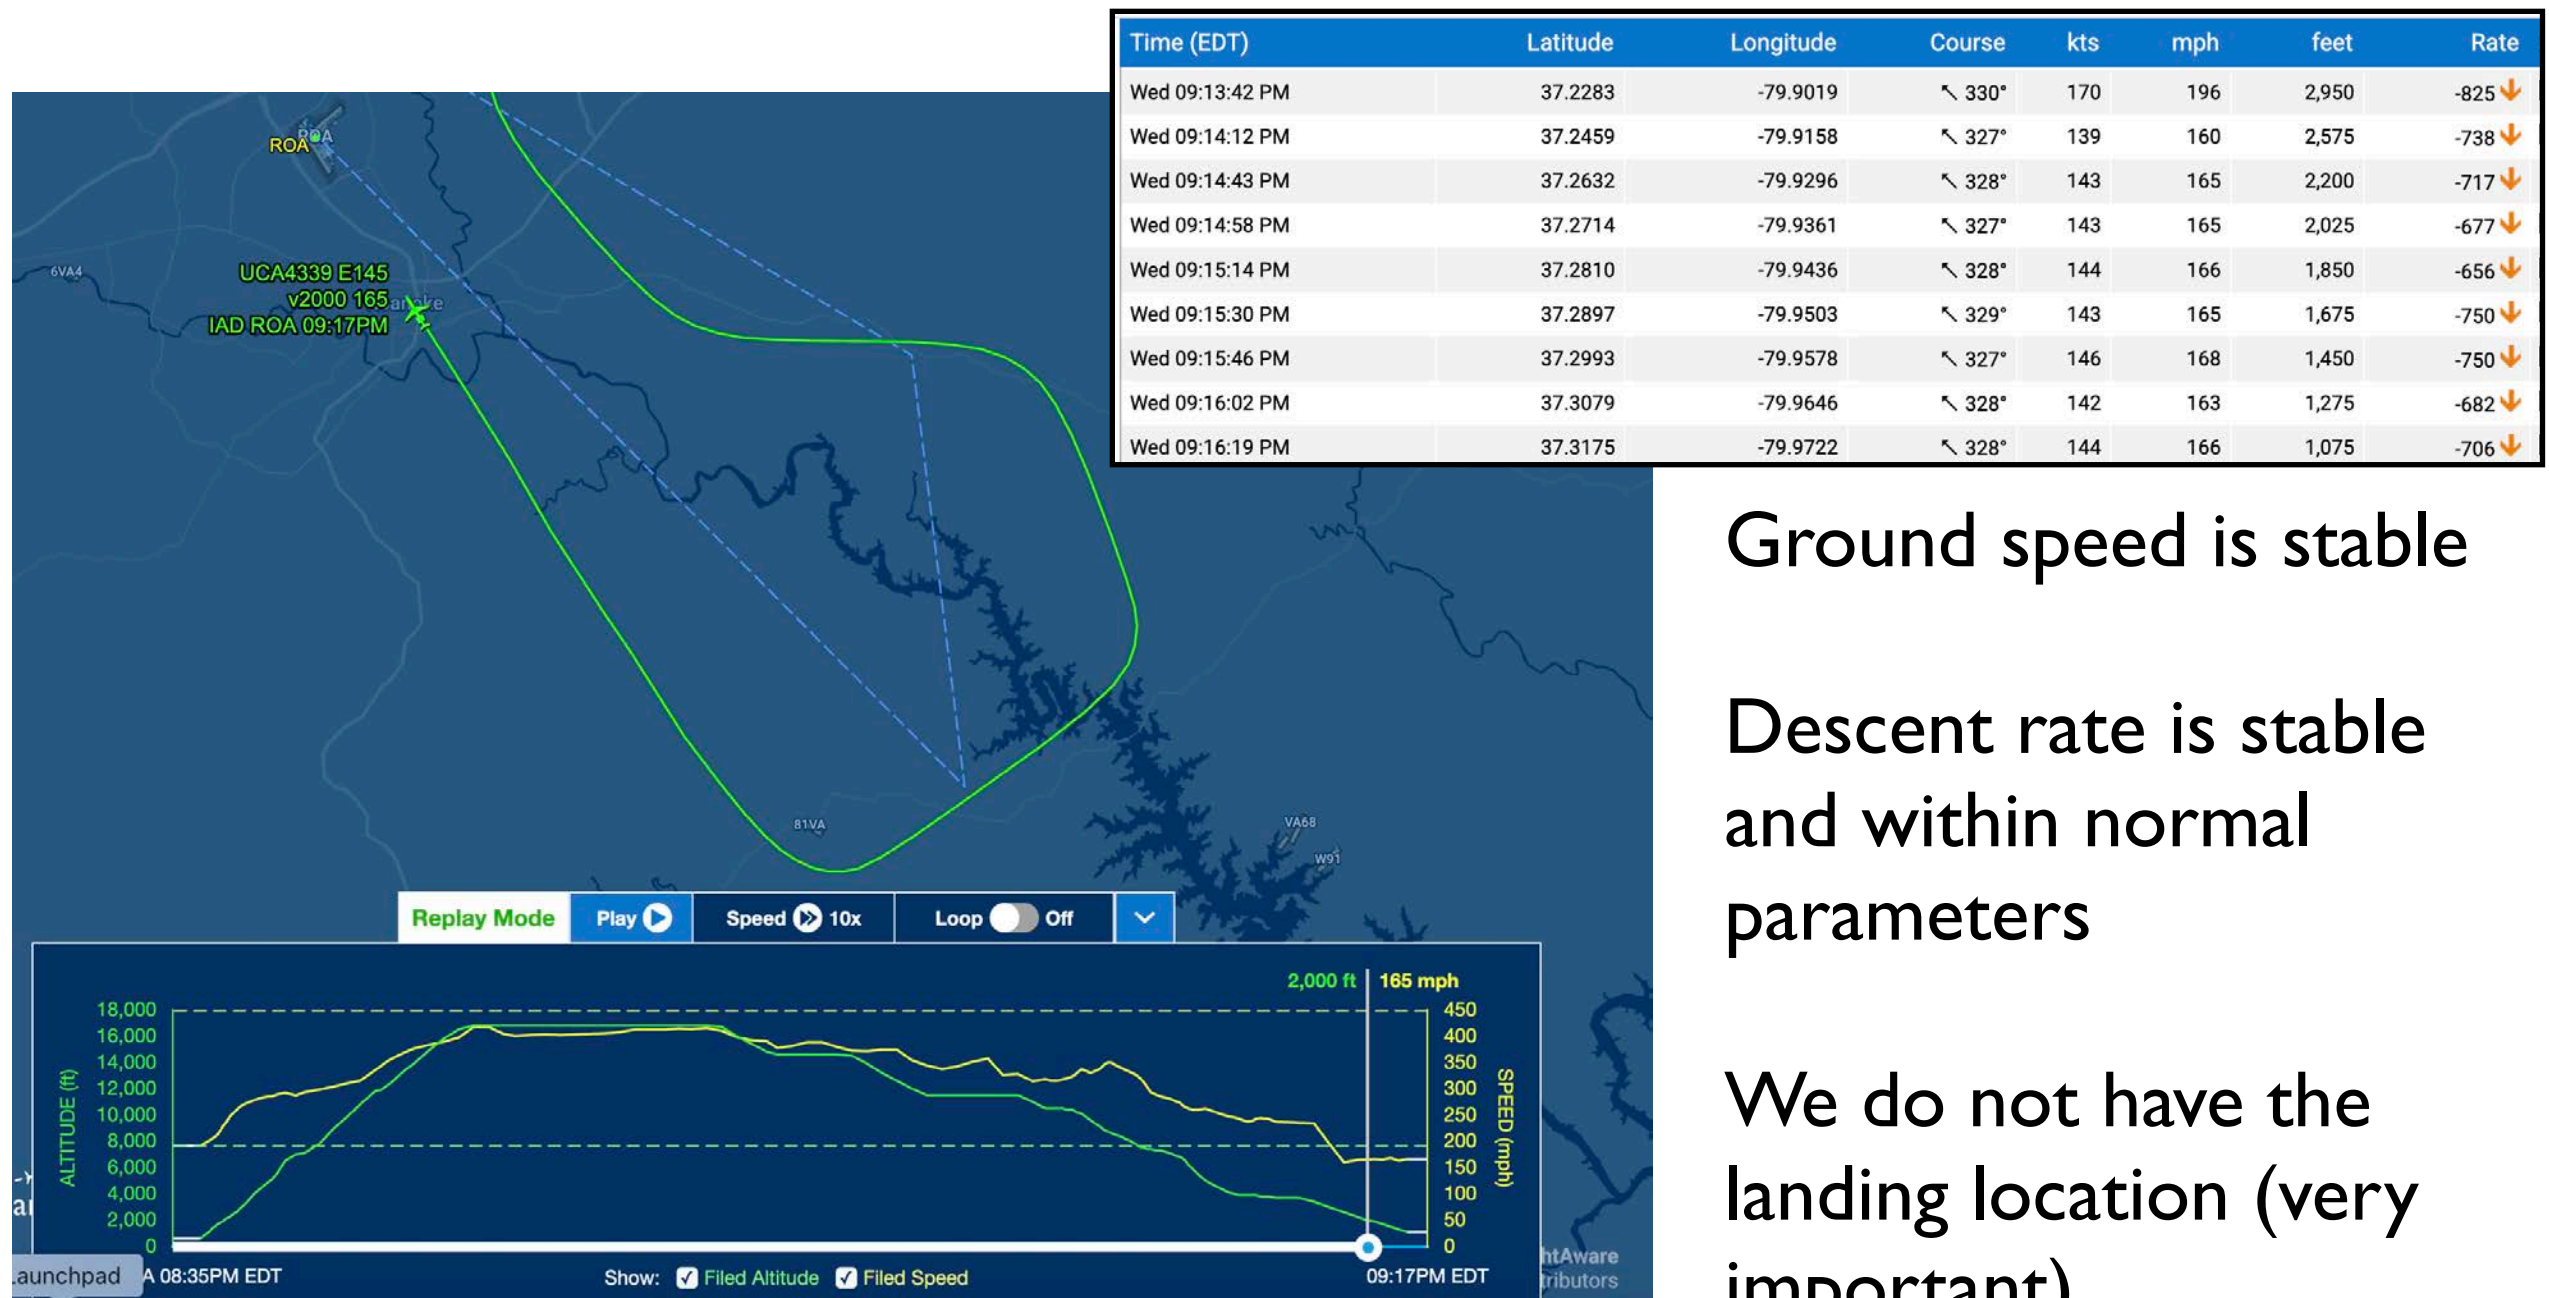
Flight parameters prior to touchdown are normal

Ground speed is stable

Descent rate is stable
and within normal
parameters

We do not have the
landing location (very
important)

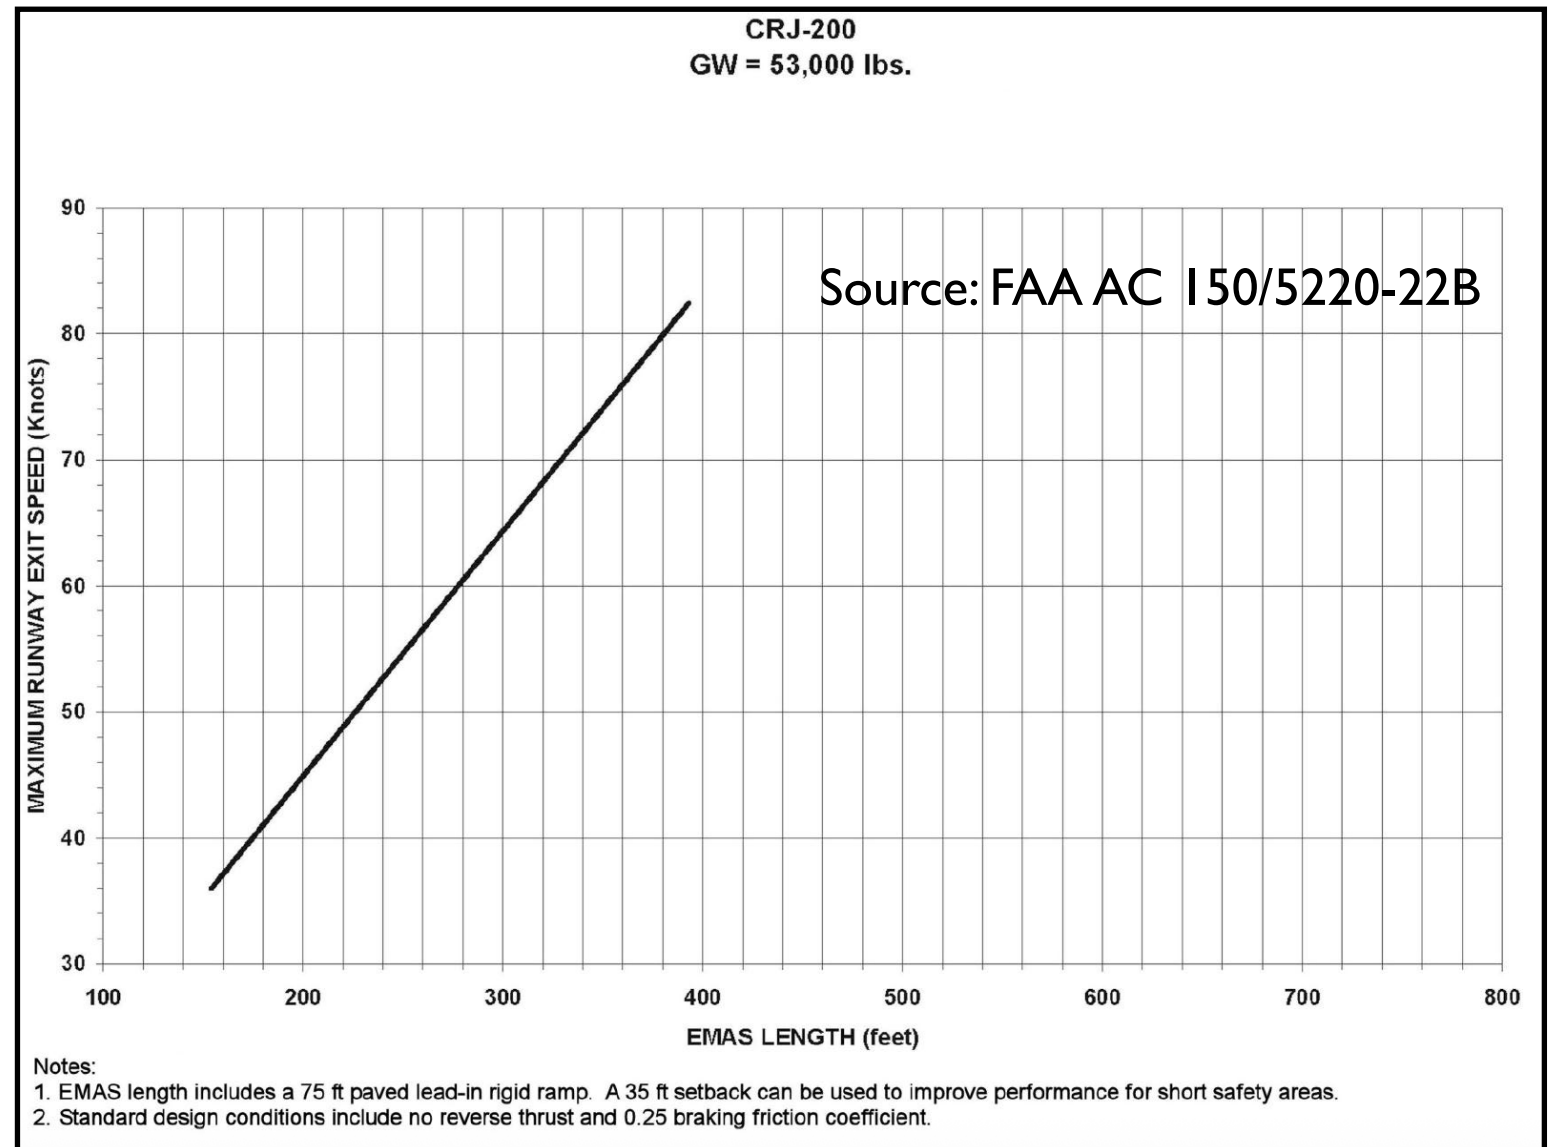
Max. Takeoff Weight = 53,000 lbs.
Typical landing weight = 45,000 lbs.
EMAS chart similar to the Bombardier CRJ-200 (53,000 lbs)

The 300-foot EMAS can stop the regional jet while departing the runway at 64 knots
The 300-foot offset provides another 8-10 knots of deceleration before entering the EMAS bed

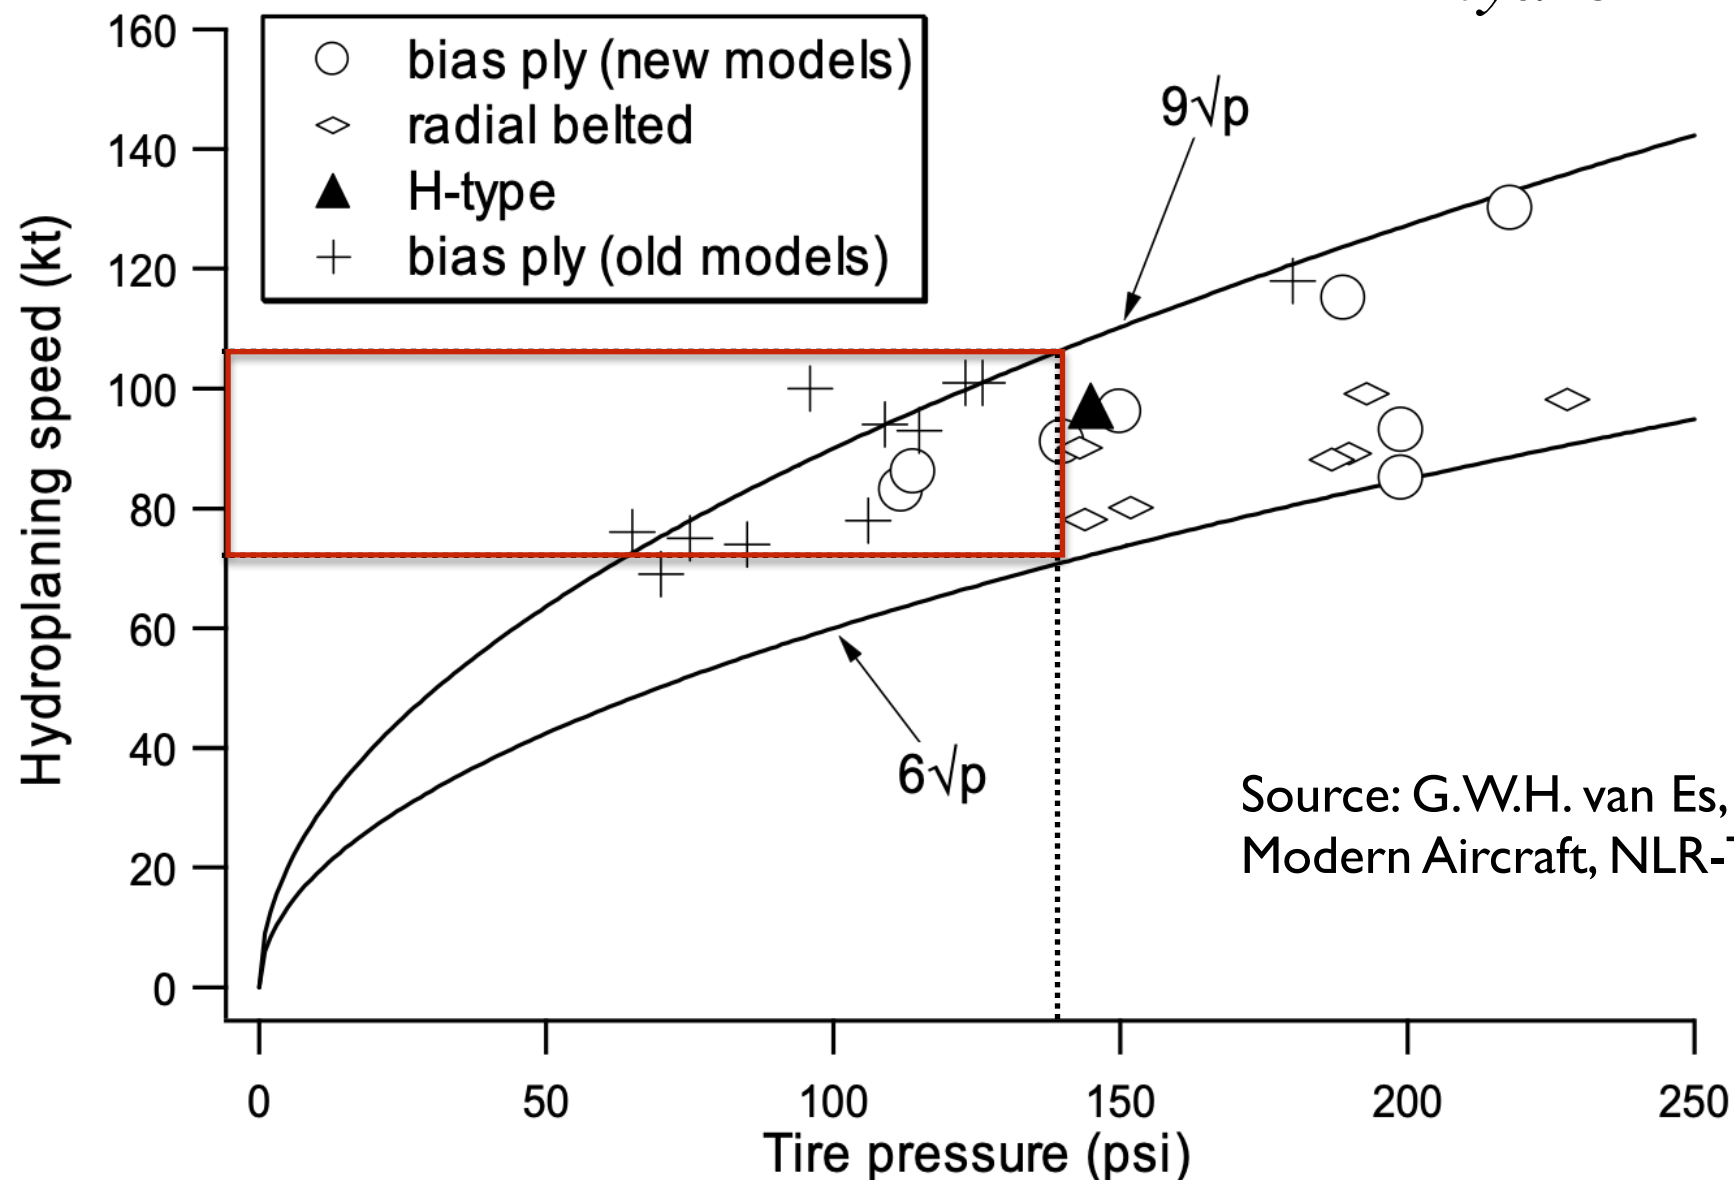
Figure 2: Experimental hydroplaning speeds as function of tire pressure for different tire types.

E145X uses tire size 30x9.5-14 main, 19.5x6.75-8 nose
Tire pressures vary from 125 to 140 lb/sq in)
